**Flood Control Project Maintenance  
Levee Inspections**

**Fall 2018 Levee Maintenance Deficiency Summary Report**

**Sacramento River Basin**

**Lake County Watershed Protection District**

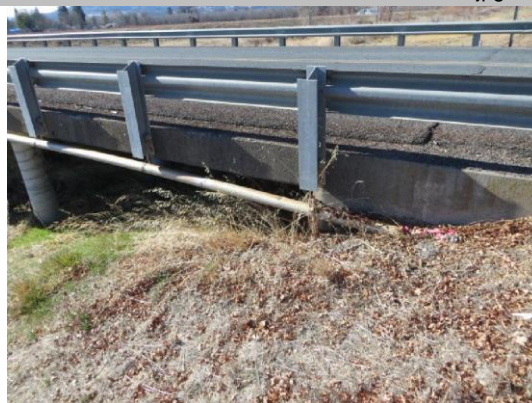
Photo 2 of 3 : UCIP\_FA\_2018\_26907\_49750.jpg

Pipe visible on upstream side of bridge.

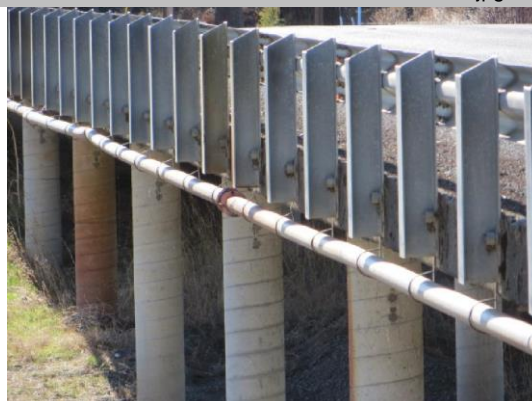
Photo 3 of 3 : UCIP\_FA\_2018\_26907\_49749.jpg

LM Start	0.53	Rating **	M	Issue No.	20 (cont)	
LM End	0.53	Issue Type +	En	Location *		
Category	Supplemental			GPS Latitude/Longitude		
				Start	End	
Item	DWR UCIP Field Study			39.176410 °	39.176410 °	
				-122.902740 °	-122.902740 °	
DWR ID	21226					
Comment Code						
Inspector Comment						
FS_ID:26907						
DS_ID:21226						
EP_NO: 6303						
Repair Type: Non-Urgent						
Crossing Status: Found						
UCIP Comments: Pipe open on waterwardside and should be plugged.						
FIELD_STRUCT_DESC: 4-inch steel irrigation pipe through the levee,						
1.5 feet below the crown. Steel cutoff wall around the pipe at center of						
levee. Pipe connects to 4-inch exposed aluminum pipe connected to						
upstream side of bridge. (Permit No. 6303-A, 1968 - John M. Siseuich).						
[Additional Reference(s): DWR Levee Log, 2005].						
FS Date: 1/9/2014

Pipe visible on upstream side of bridge.

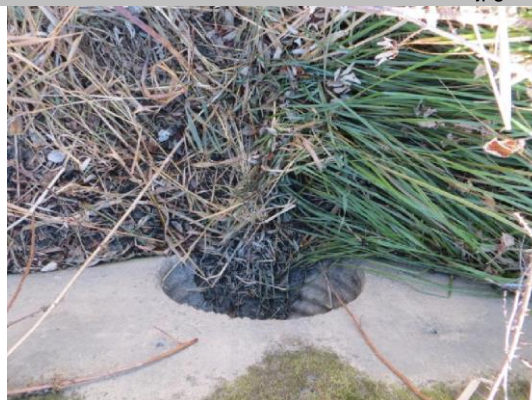
Photo 2 of 3 : UCIP\_FA\_2018\_53332\_49753.jpg

Pipe and concrete headwall visible in drainage channel on LS toe.

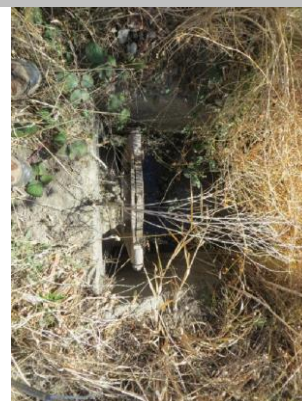
Photo 3 of 3 : UCIP\_FA\_2018\_53332\_49752.jpg

Item	DWR UCIP LMA Responsibility			39.177676°	39.177676°
				-122.898917°	-122.898917°
DWR ID	21227				
Comment Code					
Inspector Comment					
<p>FS_ID:53332 DS_ID:21227 EP_NO: 11501 Repair Type: Urgent Crossing Status: Found UCIP Comments: 9/6/2018 Same as last inspection; crossing remains Urgent because of pipe integrity (D. Sanoski - DWR UCIP).11/30/2016 Clover Creek has significant sediment build up that blocks the outlet. Crossing is still in use to drain water from LS to WS according to LMA representative, Scott Webb. (O. Magana - DWR UCIP)01/09/2014 Pipe rusted through at connection to flapgate. Good indication pipe may need replacement. Video inspection recommended. (W. Wylie - DWR UCIP) FIELD_STRUCT_DESC: 24-inch corrugated metal (CM) drainage pipe through the levee, 13.8 feet below the crown. Flap gate is located on the waterside (WS) end. Concrete headwalls located on both the WS and landside (LS) ends. (24-inch pipe [HLM 0.77] was retained under Automatic Board Order (ABO) issued as Permit No. 11501, 1975 - Sisevich). [Additional Reference(s): DWR Levee Log, 2005. USACE Sacramento O&amp;M Manual Unit 506.2, August 1961, (HLM 0.77)]. FS Date: 9/6/2018 3:49:00 PM</p>

Flapgate at concrete headwall on WS toe.

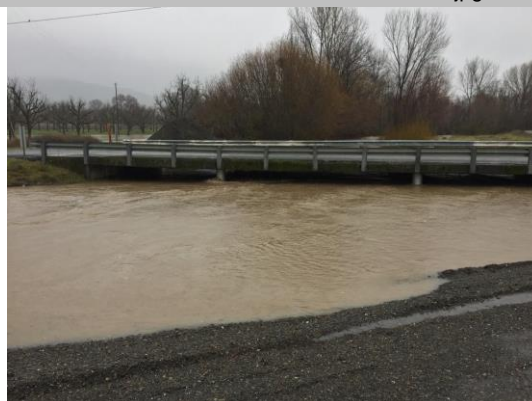
Photo 2 of 2 : LEVAL\_FA\_2018\_18\_335.jpg

LM Start	0.99	Rating **	A/W	Issue No.	11 (cont)	
LM End	1.00	Issue Type +	Ma	Location *		
Category	Supplemental			GPS Latitude/Longitude		
				Start		End
Item	2017 Storm Damage			39.179715 °		39.179916 °
				-122.896926 °		-122.896970 °
DWR ID	DWR_NA0009_04_f_2017_11					
Comment Code						
Inspector Comment						
Levee Evaluation Comments						
Description:						
Site ID No:18						
Site Designation:LMA-3						
Repair Type: Erosion						
Rating:Critical						
Field Date:6/5/2017						
Notes: Erosion begins at the edge of the patrol road. Slope is covered in loose gravel, washes out every high water season.

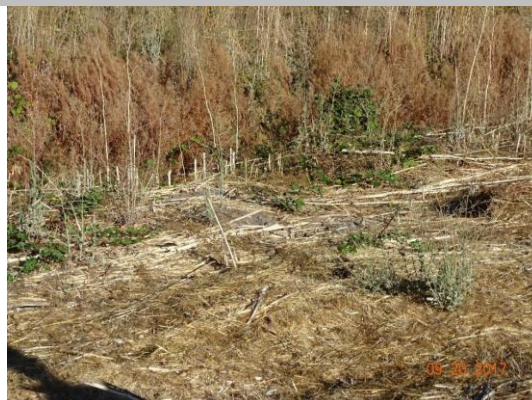
Photo 1 of 1 : FA\_2018\_NA0009\_6\_12\_20180905\_00005.jpg

LM Start	1.19	Rating **	A/W	Issue No.	12
LM End	1.19	Issue Type +	Ma	Location *	LS
Category	Earthen Levee			GPS Latitude/Longitude	
				Start	End
Item	Animal Control			39.182082 °	39.182082 °
				-122.895062 °	-122.895062 °
DWR ID	DWR_NA0009_04_f_2017_12				
Comment Code					
A3 : No rodents visible, but rodent burrows visible; need to backfill and compact or grout burrows.					
Inspector Comment					
Remove the rodent holes from the landside toe.

View of the rodent holes along the landside slope &amp; toe.

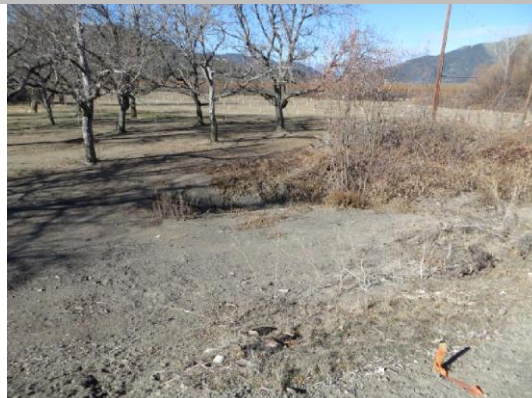
Photo 1 of 3 : UCIP\_FA\_2018\_26924\_49762.jpg

LM Start	1.19	Rating **	A/W	Issue No.	22
LM End	1.19	Issue Type +	Ma	Location *	
Category	Supplemental			GPS Latitude/Longitude	
				Start	End
Item	DWR UCIP LMA Responsibility			39.182079 °	39.182079 °
				-122.895038 °	-122.895038 °
DWR ID	21228				
Comment Code					
Inspector Comment					
FS_ID:26924					
DS_ID:21228					
EP_NO: 11496					
Repair Type: No Action Needed					
Crossing Status: Found					
UCIP Comments:					
FIELD_STRUCT_DESC: 42-inch corrugated metal drainage pipe through the levee, 8 feet below the crown. Flap gate on the waterside (WS) end. Concrete headwalls on both ends. (24-inch pipes [HLM 1.21] retained under Automatic Board Order (ABO) issued as Permit No. 11496, 1975 - Earl Foutch). [Additional Reference(s): DWR Levee Log, 2005. USACE Sacramento O&M Manual 506.2, August 1961, (HLM 1.21)].					
FS Date: 1/9/2014

Drainpipe visible at LS toe.

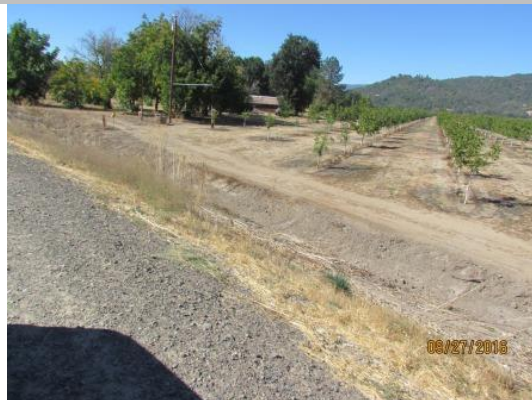
Photo 1 of 1 : FA\_2018\_NA0009\_6\_13\_20180905\_00006.jpg

LM Start	1.19	Rating **	M	Issue No.	13
LM End	1.25	Issue Type +	En	Location *	LS
Category	Earthen Levee			GPS Latitude/Longitude	
				Start	End
Item	Encroachments			39.182161 °	39.182862 °
				-122.894983 °	-122.894505 °
DWR ID	DWR_NA0009_04_f_2016_13				
Comment Code					
DT : Ditch					
Inspector Comment

View of a ditch at the landside toe looking downstream.

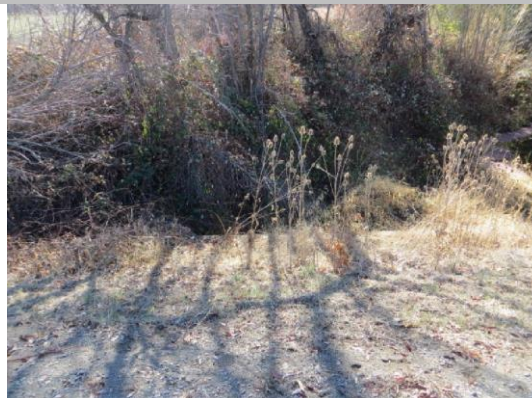
Photo 2 of 3 : UCIP\_FA\_2018\_26897\_49711.jpg

Comment Code						
Inspector Comment						
FS_ID:26897 DS_ID:21235 EP_NO: 11507 Repair Type: Non-Urgent Crossing Status: Found UCIP Comments: 10/27/2017 This structure is inspected annually under the Structure and Channel Summer Inspection (part of the Levee Inspection Program) conducted by the DWR Flood Project Integrity and Inspection Branch (FPIIB). (DWR UCIP - O. Magana) Some sediment buildup at LS toe. FIELD_STRUCT_DESC: [Clover Creek Diversion Structure] 1 of 6: 36-inch corrugated metal drainage pipe through the levee, 12 feet below the crown. Slide gate on the waterside (WS) end. Steel walkway on the WS slope to slide gate. Concrete headwall on both ends. (six 36-inch pipes and structure [HLM 0.3] retained under Automatic Board Order (ABO) issued as Permit No. 11507, 1975 - Lake County Flood Control and Water Conservation District). [Additional Reference(s): DWR Levee Log, 2005. USACE Sacramento O&M Manual 506, Part 2, August 1961, (HLM 0.31)]. FS Date: 1/9/2014

Outlet visible at concrete headwall on LS toe.

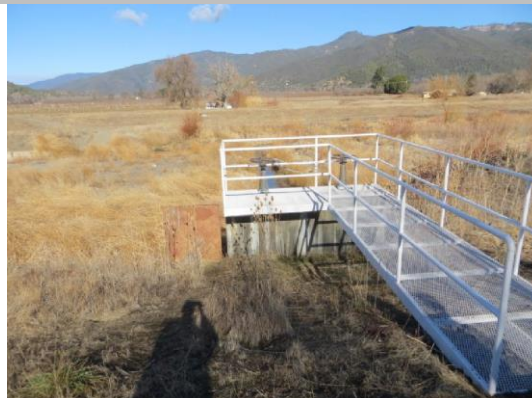
Photo 1 of 3 : UCIP\_FA\_2018\_26891\_49682.jpg

Comment Code					
Inspector Comment					
FS_ID:26891 DS_ID:21234 EP_NO: 11507 Repair Type: Non-Urgent Crossing Status: Found UCIP Comments: 10/27/2017 This structure is inspected annually under the Structure and Channel Summer Inspection (part of the Levee Inspection Program) conducted by the DWR Flood Project Integrity and Inspection Branch (FPIIB). (DWR UCIP - O. Magana) Some sediment buildup on LS toe. FIELD_STRUCT_DESC: [Clover Creek Diversion Structure] 2 of 6: 36-inch corrugated metal drainage pipe through the levee, 12 feet below the crown. Slide gate on the waterside (WS) end. Steel walkway on the WS slope to slide gate. Concrete headwalls on both ends. (six 36-inch pipes and structure [HLM 0.3] retained under Automatic Board Order (ABO) issued as Permit No. 11507, 1975 - Lake County Flood Control and Water Conservation District). [Additional Reference(s): DWR Levee Log, 2005. USACE Sacramento O&M Manual 506, Part 2, August 1961, (HLM 0.31)]. FS Date: 1/9/2014

Slide gate on steel walkway at WS toe.

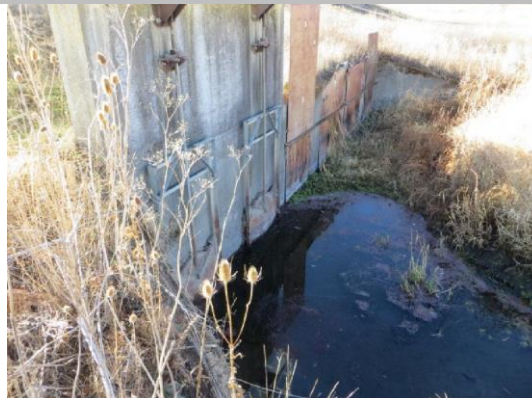
Photo 3 of 3 : UCIP\_FA\_2018\_26891\_49680.jpg

Comment Code						
Inspector Comment						
FS_ID:26891 DS_ID:21234 EP_NO: 11507 Repair Type: Non-Urgent Crossing Status: Found UCIP Comments: 10/27/2017 This structure is inspected annually under the Structure and Channel Summer Inspection (part of the Levee Inspection Program) conducted by the DWR Flood Project Integrity and Inspection Branch (FPIIB). (DWR UCIP - O. Magana) Some sediment buildup on LS toe. FIELD_STRUCT_DESC: [Clover Creek Diversion Structure] 2 of 6: 36-inch corrugated metal drainage pipe through the levee, 12 feet below the crown. Slide gate on the waterside (WS) end. Steel walkway on the WS slope to slide gate. Concrete headwalls on both ends. (six 36-inch pipes and structure [HLM 0.3] retained under Automatic Board Order (ABO) issued as Permit No. 11507, 1975 - Lake County Flood Control and Water Conservation District). [Additional Reference(s): DWR Levee Log, 2005. USACE Sacramento O&M Manual 506, Part 2, August 1961, (HLM 0.31)]. FS Date: 1/9/2014

Slide gate visible at concrete headwall on WS toe.

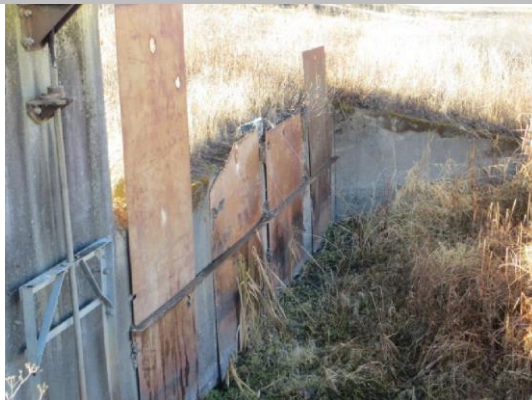
Photo 3 of 3 : UCIP\_FA\_2018\_26888\_49664.jpg

Comment Code						
Inspector Comment						
FS_ID:26888 DS_ID:21233 EP_NO: 11507 Repair Type: Non-Urgent Crossing Status: Found UCIP Comments: 10/27/2017 This structure is inspected annually under the Structure and Channel Summer Inspection (part of the Levee Inspection Program) conducted by the DWR Flood Project Integrity and Inspection Branch (FPIIB). (DWR UCIP - O. Magana) Some sediment buildup at outlet on LS toe. FIELD_STRUCT_DESC: [Clover Creek Diversion Structure] 3 of 6: 36-inch corrugated metal drainage pipe through the levee, 12 feet below the crown. Concrete headwall on both ends. Steel slide gate plate blocks inlet on the waterside (WS) toe. (six 36-inch pipes and structure [HLM 0.3] retained under Automatic Board Order (ABO) issued as Permit No. 11507, 1975 - Lake County Flood Control and Water Conservation District). [Additional Reference(s): DWR Levee Log, 2005. USACE Sacramento O&M Manual 506, Part 2, August 1961, (HLM 0.31)]. FS Date: 1/9/2014

Steel slide gate visible at concrete headwall on WS toe.

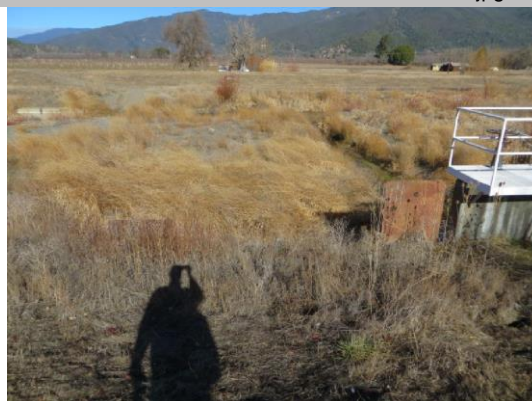
Photo 1 of 3 : UCIP\_FA\_2018\_26883\_49622.jpg

Metal slide gate visible at concrete headwall on WS toe.

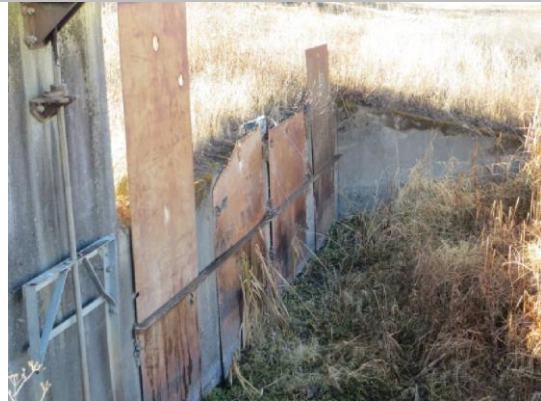
Photo 3 of 3 : UCIP\_FA\_2018\_26883\_49620.jpg

Comment Code						
Inspector Comment						
FS_ID:26883 DS_ID:21231 EP_NO: 11507 Repair Type: Non-Urgent Crossing Status: Found UCIP Comments: 10/27/2017 This structure is inspected annually under the Structure and Channel Summer Inspection (part of the Levee Inspection Program) conducted by the DWR Flood Project Integrity and Inspection Branch (FPIIB). (DWR UCIP - O. Magana) Some sediment buildup on LS toe. FIELD_STRUCT_DESC: [Clover Creek Diversion Structure] 5 of 6: 36-inch corrugated metal drainage pipe through the levee, 12 feet below the crown. Concrete headwall on both ends. Steel slide gate blocks inlet on the waterside (WS) toe. (six 36-inch pipes and structure [HLM 0.3] retained under Automatic Board Order (ABO) issued as Permit No. 11507, 1975 - Lake County Flood Control and Water Conservation District). [Additional Reference(s): DWR Levee Log, 2005. USACE Sacramento O&M Manual 506, Part 2, August 1961, (HLM 0.31)]. FS Date: 1/9/2014

Metal slide gate visible at concrete headwall on WS toe.

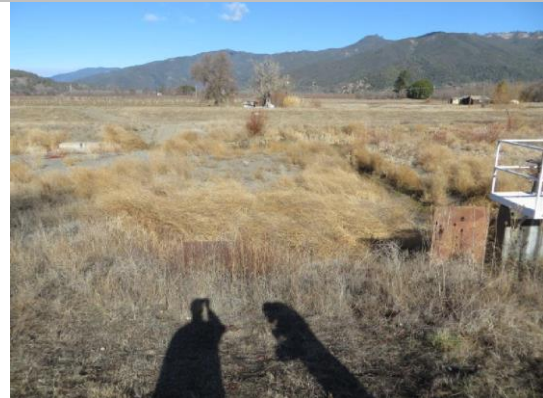
Photo 1 of 3 : UCIP\_FA\_2018\_26877\_49610.jpg

Steel slide gate visible at headwall on WS toe.

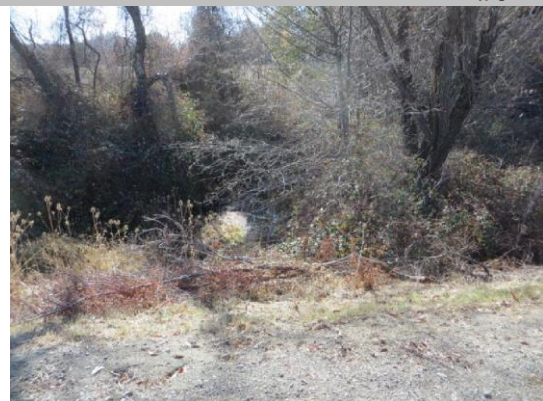
Photo 2 of 3 : UCIP\_FA\_2018\_26877\_49609.jpg

Concrete headwall on LS toe.

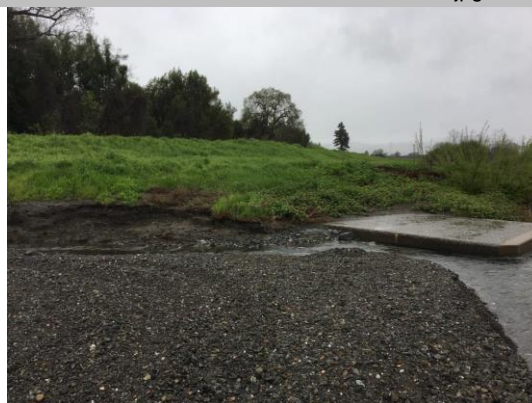
Photo 1 of 3 : LEVAL\_FA\_2018\_19\_352.jpg

LM Start	0.32	Rating **	A/W	Issue No.	13
LM End	0.32	Issue Type +	Ma	Location *	
Category	Supplemental			GPS Latitude/Longitude	
				Start	End
Item	2017 Storm Damage			39.177150 °	39.177150 °
				-122.899111 °	-122.899111 °
DWR ID	DWR_NA0009_05_f_2017_13				
Comment Code					
Inspector Comment					
Levee Evaluation Comments					
Description:					
Site ID No:19					
Site Designation:LCWPD-01					
Repair Type: Erosion					
Rating:Area of Concern					
Field Date:6/5/2017					
Notes: Erosion exists between a small weir and diversion pipes.

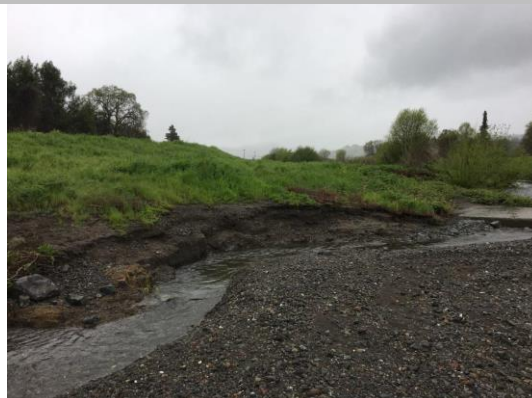
Photo 2 of 3 : LEVAL\_FA\_2018\_19\_354.jpg

LM Start	0.32	Rating **	A/W	Issue No.	13 (cont)	
LM End	0.32	Issue Type +	Ma	Location *		
Category	Supplemental			GPS Latitude/Longitude		
				Start		End
Item	2017 Storm Damage			39.177150 °		39.177150 °
				-122.899111 °		-122.899111 °
DWR ID	DWR_NA0009_05_f_2017_13					
Comment Code						
Inspector Comment						
Levee Evaluation Comments						
Description:						
Site ID No:19						
Site Designation:LCWPD-01						
Repair Type: Erosion						
Rating:Area of Concern						
Field Date:6/5/2017						
Notes: Erosion exists between a small weir and diversion pipes.

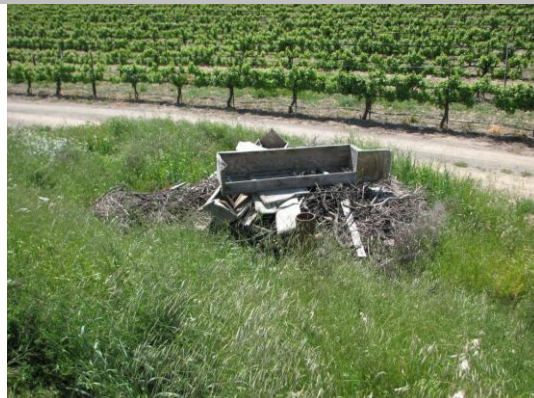
Photo 1 of 1 : FA\_2018\_NA0009\_7\_10\_20180905\_00001.jpg

LM Start	0.63	Rating **	M	Issue No.	10
LM End	0.63	Issue Type +	En	Location *	LS
Category	Earthen Levee			GPS Latitude/Longitude	
				Start	End
Item	Encroachments			39.175758 °	39.175758 °
				-122.904353 °	-122.904353 °
DWR ID	DWR_NA0009_05_s_2016_10				
Comment Code					
DE : Debris					
Inspector Comment					
Remove prunings and wooden lumber debris.

5/2/2016: Remove prunings and lumber debris from L/S toe.

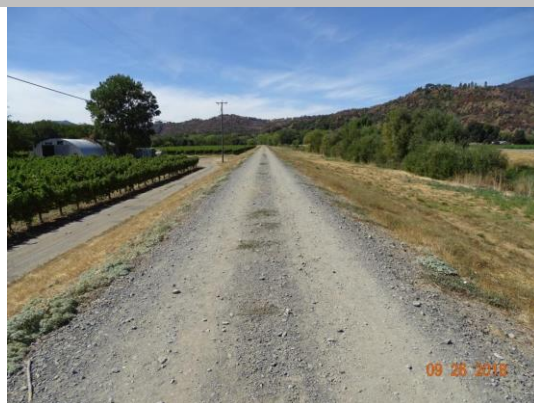
Photo 1 of 1 : FA\_2018\_NA0009\_7\_11\_20181009\_00026.jpg

LM Start	0.69	Rating **	A	Issue No.	11
LM End	0.69	Issue Type +	Ma	Location *	LS
Category	Earthen Levee			GPS Latitude/Longitude	
				Start	End
Item	Vegetation			39.175785 °	39.175785 °
				-122.905585 °	-122.905585 °
DWR ID	DWR_NA0009_05_f_2018_11				
Comment Code					
V1 : Control annual grass and weeds on the levee slopes and easements.					
Inspector Comment					
The vegetation was removed from both slopes.

View of no vegetation on both slopes.

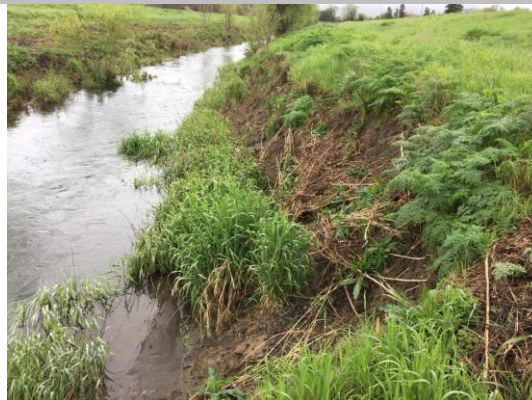
Photo 1 of 3 : LEVAL\_FA\_2018\_20\_340.jpg

LM Start	0.82	Rating **	A/W	Issue No.	20
LM End	0.86	Issue Type +	Ma	Location *	
Category	Supplemental			GPS Latitude/Longitude	
				Start	End
Item	2017 Storm Damage			39.175740°	39.175750°
				-122.907980°	-122.908710°
DWR ID	DWR_NA0009_05_f_2017_20				
Comment Code					
Inspector Comment					
Levee Evaluation Comments					
Description:					
Site ID No:20					
Site Designation:LCWPD-02					
Repair Type: Erosion					
Rating:Area of Concern					
Field Date:6/5/2017					
Notes: 5 - 7 ft deep erosion scarps, bank is normally near vertical but at a much smaller drop off, 1 - 3 ft.

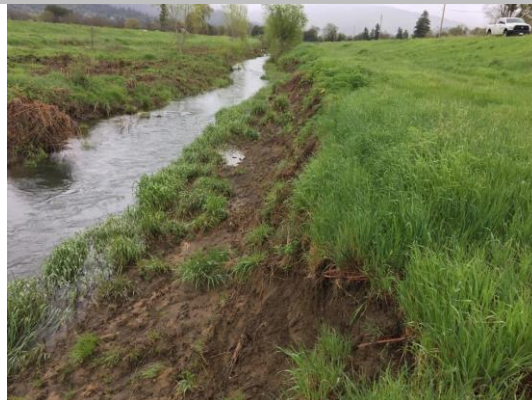
Photo 3 of 3 : LEVAL\_FA\_2018\_20\_350.jpg

LM Start	0.82	Rating **	A/W	Issue No.	20 (cont)
LM End	0.86	Issue Type +	Ma	Location *	
Category	Supplemental			GPS Latitude/Longitude	
				Start	End
Item	2017 Storm Damage			39.175740 °	39.175750 °
				-122.907980 °	-122.908710 °
DWR ID	DWR_NA0009_05_f _ 2017_20				
Comment Code					
Inspector Comment					
Levee Evaluation Comments					
Description:					
Site ID No:20					
Site Designation:LCWPD-02					
Repair Type: Erosion					
Rating:Area of Concern					
Field Date:6/5/2017					
Notes: 5 - 7 ft deep erosion scarps, bank is normally near vertical but at a much smaller drop off, 1 - 3 ft.
